SERVICE

**BULLETIN****SB #:** F115**BRANDS:**

**DATE:** JULY 2016**TO:** ALL AUTHORIZED FERRIS DEALERS**SUBJECT:** POSSIBLE MISSING GEARBOX VENT ON IS2600Z UNITS**MODELS:** SEE LIST BELOW

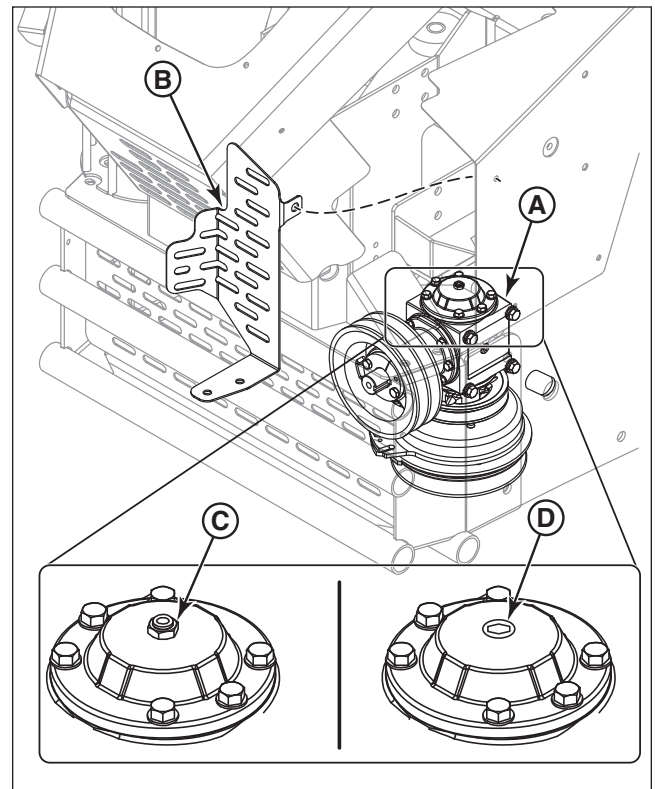
Figure 1. Inspecting the Gearbox

3. Observe the top of the gearbox (**A, Figure 1**). If the unit was shipped outside of the United States it is equipped with an additional flywheel guard (**B**). The top of the gearbox can be viewed by looking through the slots of the flywheel guard or if necessary the flywheel guard can be temporarily removed.

- If the gearbox is equipped with the raised hex vent (**C**) the gearbox vent **is installed**, continue with step # 5. **The correction procedure is not necessary.**

- If the gearbox is equipped with a round internal hex set screw (**D**) the gearbox vent **is not installed**, continue with step # 4.
4. Inspect the gearbox's lower seal (**A, Figure 2**) for oil leakage. From beneath the machine the bottom gearbox shaft seal can be viewed. If the gearbox is leaking oil there will be oil and excessive dust, grass, and debris built up.

1. If the unit does not have a vent installed and does not show signs of oil leakage order and install Kit # 5600964 - “Kit, Gearbox Vent, IS2600Z”.

If the unit does not have a vent installed and shows signs of oil leakage, order and install Kit # 5900965 - “Kit, Gearbox Replacement, IS2600Z”.
